*Relatório de
Investigação Científica INCT 2024*

**GEOSCIENCE INVESTIGATION ON NATIONAL
ROAD FAILURE AT LUGATOI AREA,
VIQUEQUE MUNICIPALITY, TIMOR LESTE**

Dili, Novembro 2024

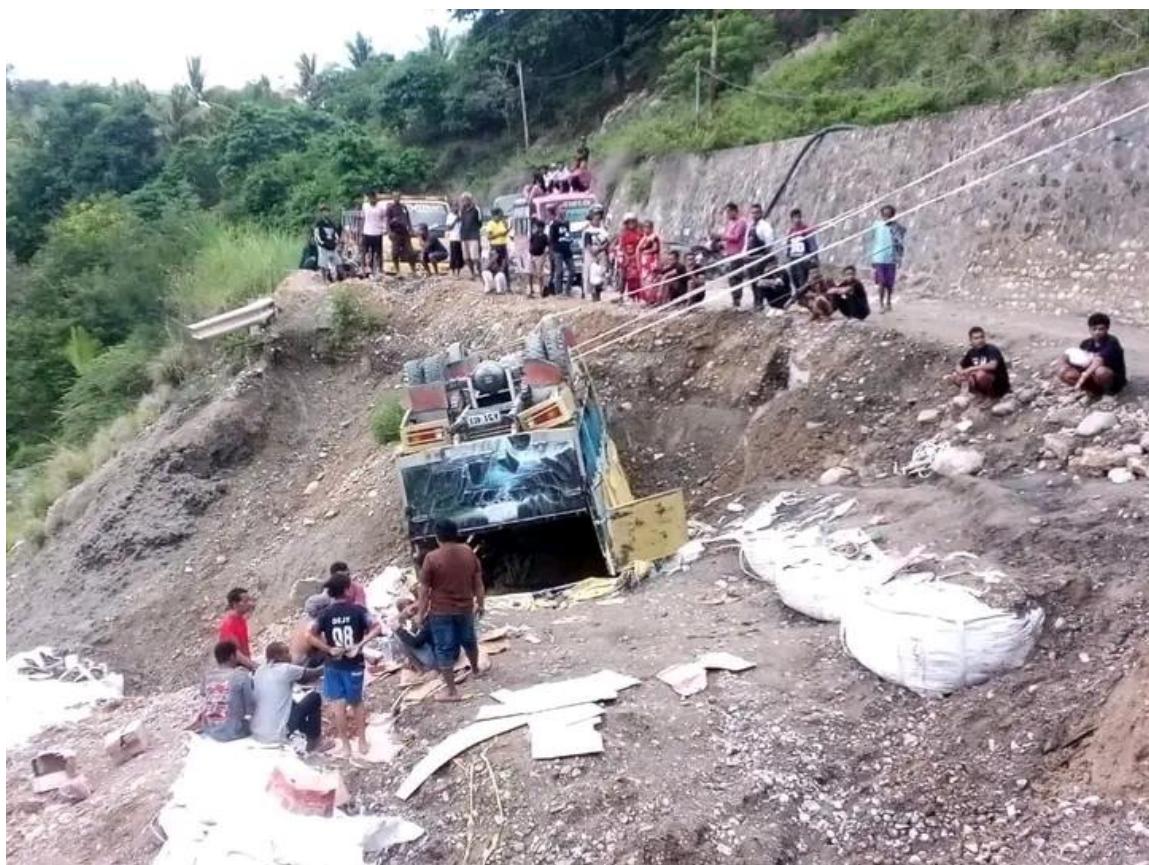
Figure 1. Road damage caused vehicle accident even lose life in February 2024 (Source: FB Santos R.)

In the last five years, the maintenance of the road has been conducted more than three times due to the road damage. In Timor-Leste obviously shows absence of geoscience involvement in various megaprojects. For instance, some section of Suai Highway coincides cross over the mud diapiric zone and highly deformed of bedding with dipping to the highway (Soares *et al*, 2022). This because, the megaproject was only responsible by Civil engineering, where they carried out Cone Penetration Testing (CPT) and standard penetration Testing (SPT) only to conduct feasibility study.

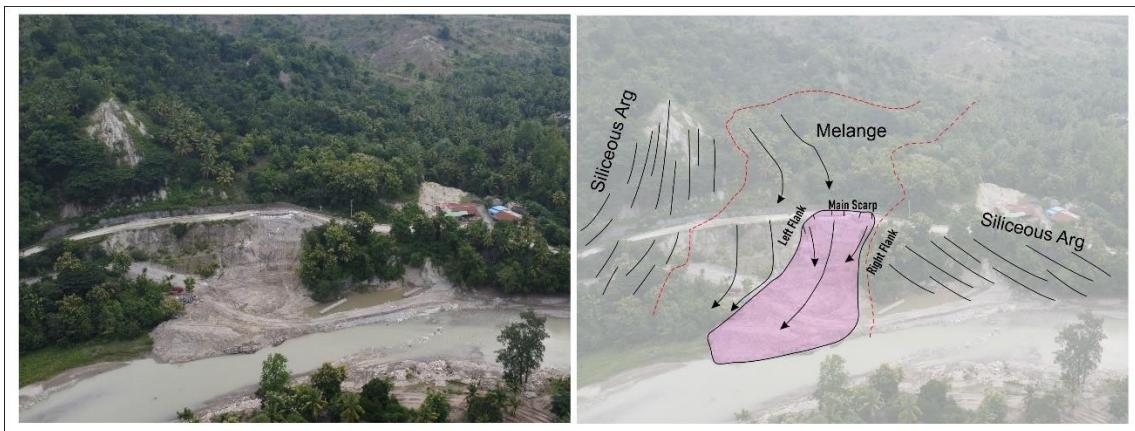
Figure 16. Interpretation of landslide according to aero photo

The aerial imagery and DTM of drone provide preliminary information prior to detailed field investigation (see Figure 15). Drones creates detailed maps and 3D models view of landslide-prone areas as display in Figure 16. These models help in understanding the topography and identifying potential risk zones. This allowing assessing the dynamics of landslides and predicting future movements. Drones can access remote or dangerous areas that are difficult for humans to reach. This makes them invaluable for surveying landslides in rugged terrains. Before proceeding to the field for ground checks, topography interpretation was conducted. This allows to understand the shape of topography that could related to the local geological structures (see Figure 16).

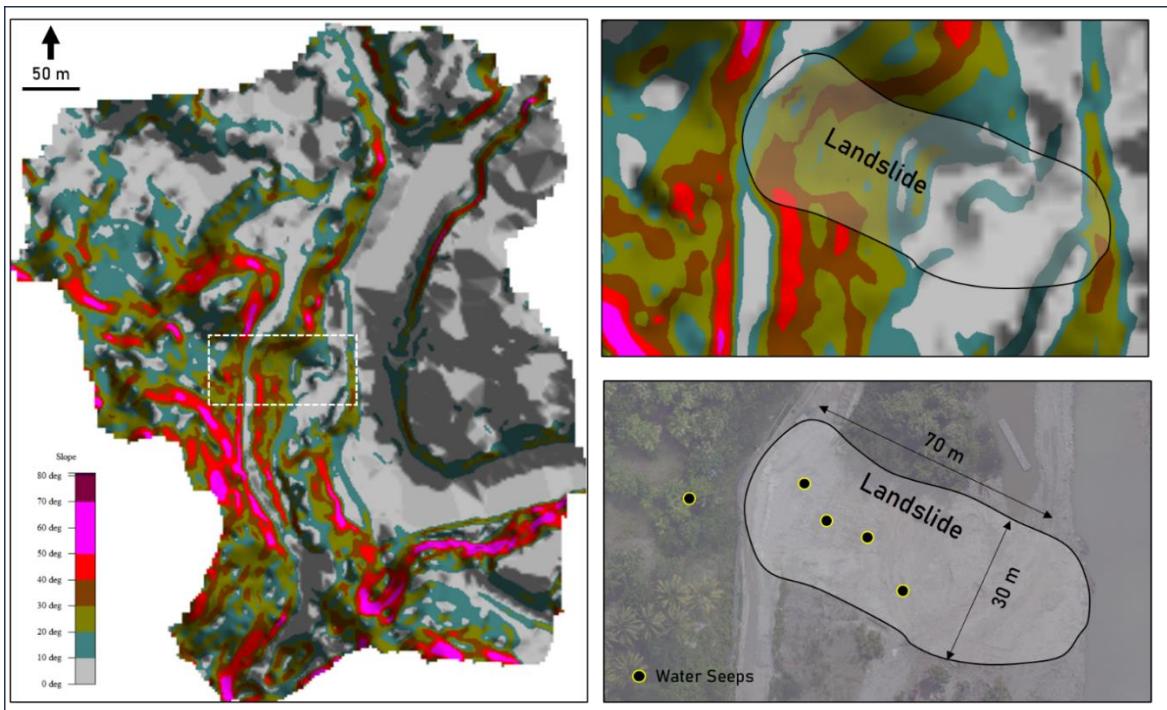
Figure 17. Slope map of study area

The Digital Terrain Model (DTM) obtained from drone imagery is useful for understanding the geomorphic changes that occur before and after a landslide. This is clearly observed on the slope map in Figure 17. Prior to the landslide and surface excavation, the slope was approximately between 40 and 50 degrees, as seen on the left and right flanks of the landslide, where the terrain is steep. Due to the unstable slope in the area, which is mostly covered by clay, the material moved downslope, altering the landscape and consequently causing road failure. The length of landslide extends from the main scarp precisely on the road failure down to the river is around 70 m. Its width approximately 30 m from the left to right flank of landslide. Further to the high elevation, around 35 m a small landslide occurred with length and width 10 m and 7 m respectively (see Figure 17).

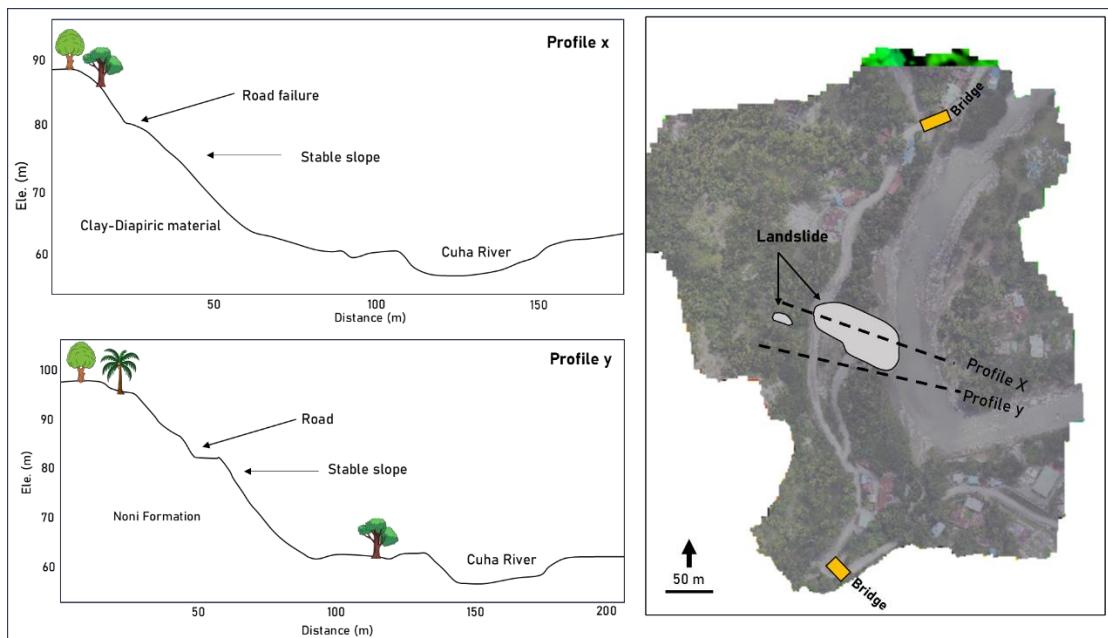
Figure 18. Elevation profiles of stable and unstable slope

Figure 18 shows two different elevation profiles. Profile X indicates the slope of the geomorphology along the landslide, while Profile Y represents the area beyond the landslide zone. Both profiles display differences in terrain shape. Initially, they had similar features with slopes around 40 to 50 degrees. However, the landslide altered the surface terrain along the landslide zone. The elevation at the point of road failure is approximately 85 meters above sea level. The landslide occurred on the area mostly

covered by the clay. While the area which occupied by the siliceous argillite does not interrupt by the landslide.

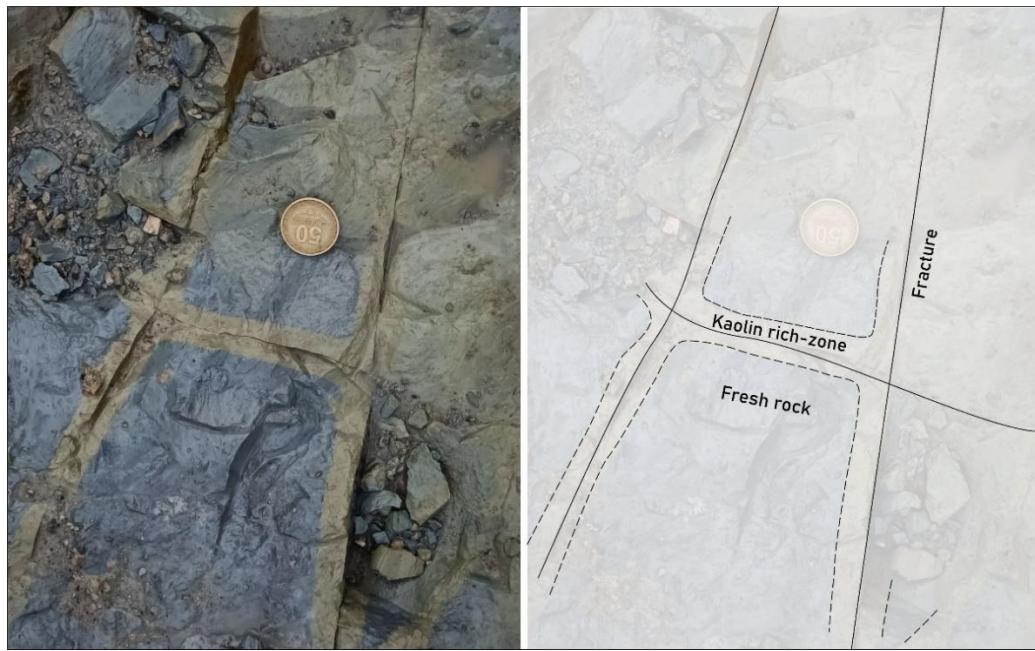
These geological structures allowing water infiltration into rock, presence of water considerably influences the geotechnical slope stability Therefore, identifying distribution of fault is crucial due to rock water weakening effect prone to unstable slope during high rainfall. Noni formation itself rich of clay particle where water has a greater influence on the rock. Increasing of water infiltration into fault and easily expands and disintegrates after being saturated with water.

Figure 27. Kaolin rich zone formed along the joint on siliceous argillite

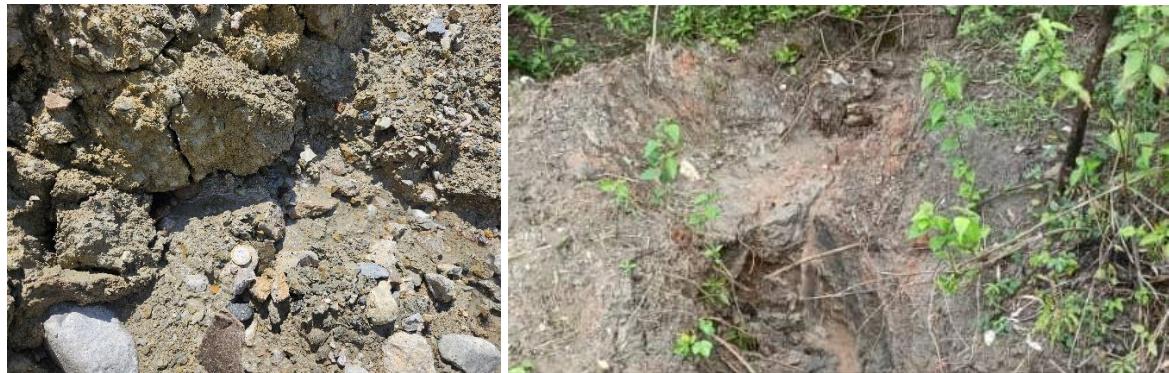
Figure 29. Natural Spring emerge in the landslide (left), poor surface drainage in the highland (right)

Poor drainage around the diapiric zone is one of the most issues was observed. Infiltration of surface through the open crack in the highest elevation flowing underneath of subsurface then emerge on the surface (natural spring) in the location of slope failure (see Figure 29).

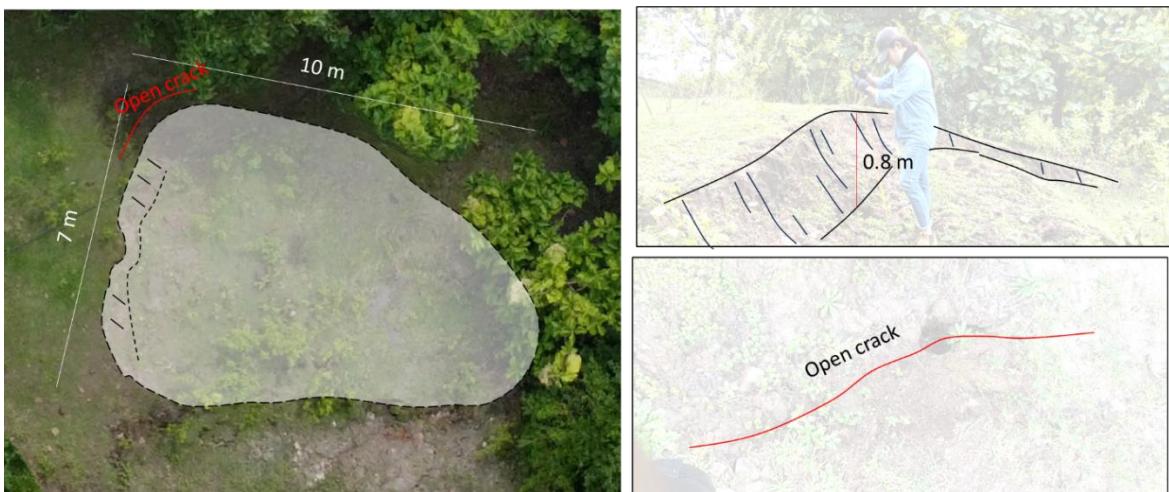
Figure 30. Obvious landslide in the highland.

The observation concluded that the material has high plasticity and this exhibits significant volume changes with variations in moisture content. This volume change over time is the main cause that led to landslide which is demolishing the road in Lugatoi area. A small rotational landslide observed with length 10 m and width 7 m. The main scarp moved down around 0.8 m (see Figure 30).

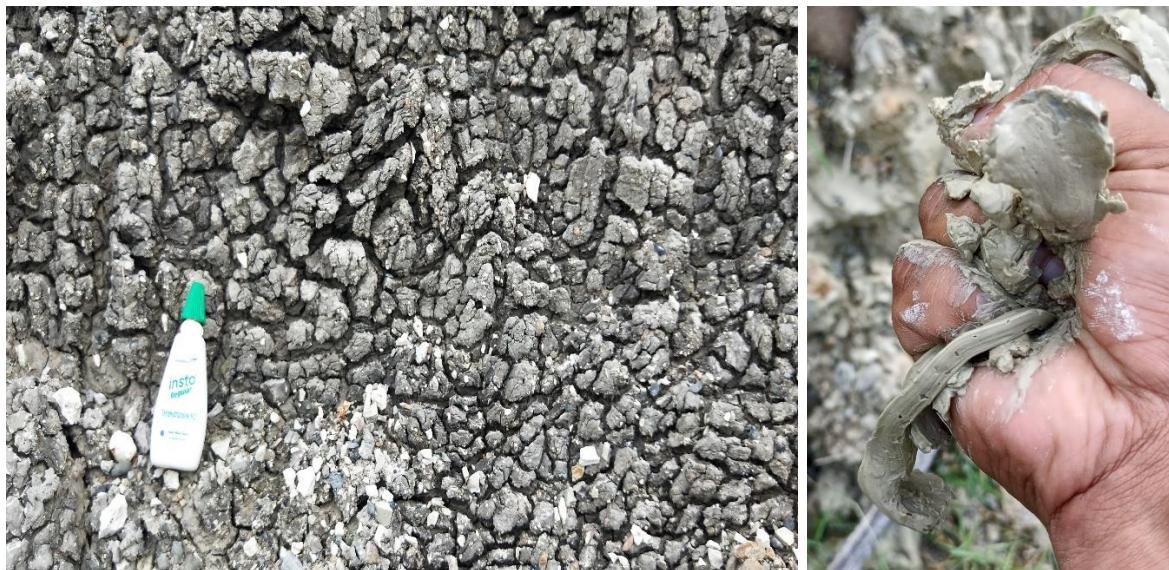
Figure 31. Cracking and plasticity test in field

Observation in field indicates shrink-swell behaviour where the dry clay has cracking this relates to loss of moisture causing it to shrink. Moreover, clay testing field shows the clay flowing out between the fingers when squeezed. This means the clay has high plasticity (see Figure 31).

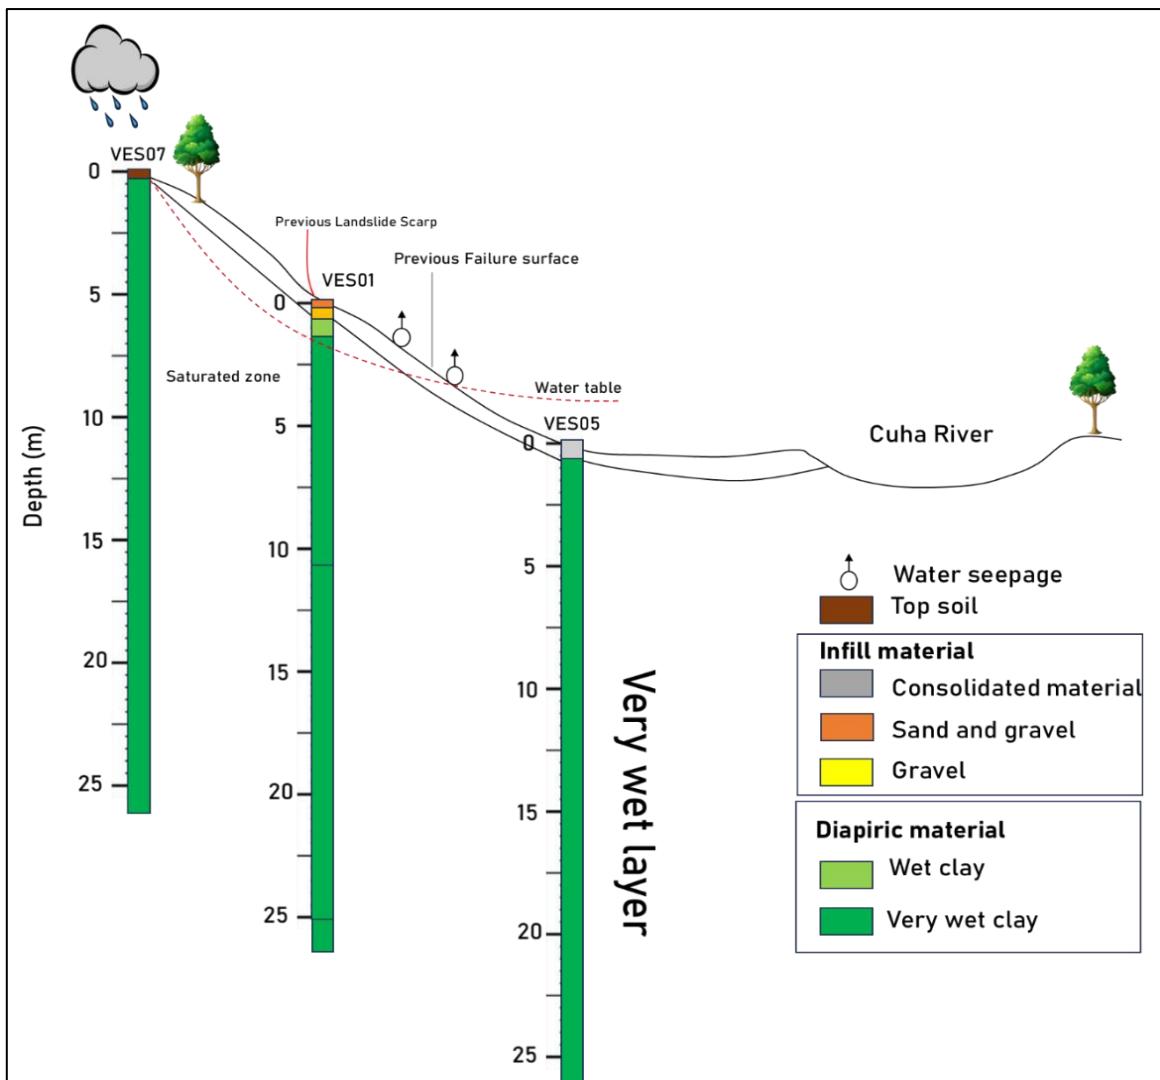
According to various data a subsurface profile was developed in Figure 35. The profile created from VES-07 in highland and VES-05 in bank of Cuha River. Along the landslide zone found numerous natural springs. Mosty the landslide occupied by very fine particle of clay. The top layer of profile considering as the dry clay, up to depth 0.5 m decreasing of resistivity value interpreted as very wet clay layer. This interpretation support by the distribution of natural spiring occurred along landslide zone. The model is agreeable to the geological observation. The excavation exposed the thickness of clay material of diapiric mélange observed from the bank river up to the highland along the strike slip fault.

Figure 35. Subsurface profile cross over the landslide zone

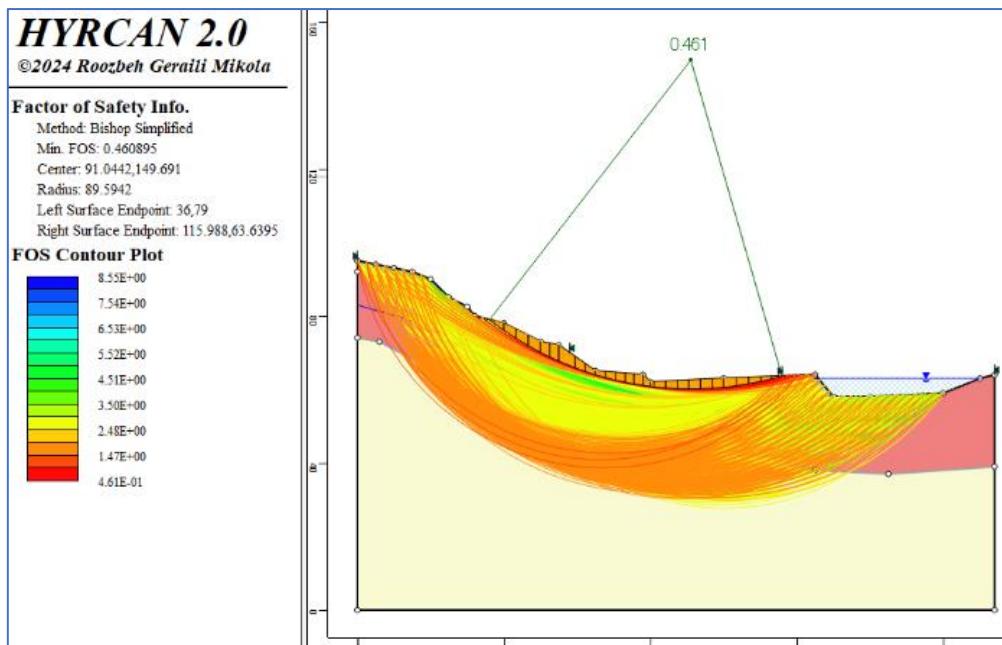
By using the Hyrcan application ver. 2.0, it is shown the value of the Safety Factor (SF) of the slope with the Simplified Bishop method has a value 0,461. Thus, it can be stated that the slope is unstable and already still in failure condition.

Figure 38. The slope stability analysis during Failure Condition

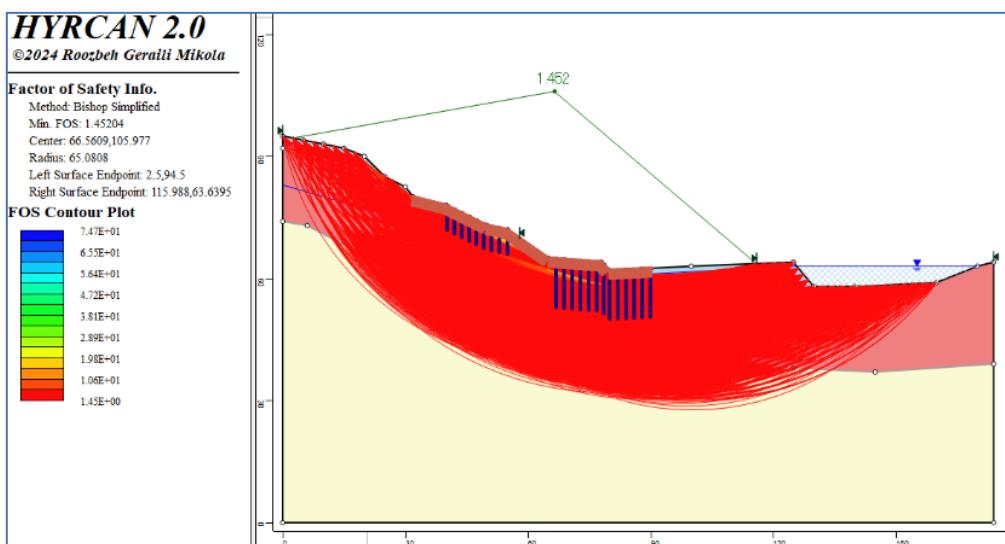
Figure 39. The slope stability analysis after reinforcing with combination of bored pile and gabions.

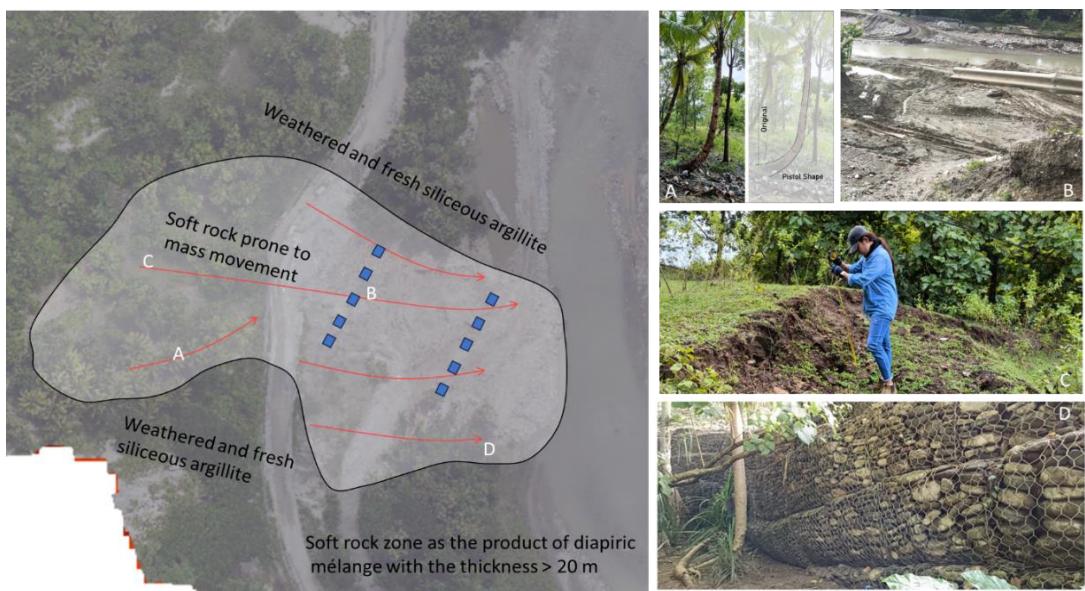
The ongoing road failure maintenance construction using the piling method with depth 6 m in the toe of landslide and 12 m depth in the middle of landslide (see Figure 41), the blue box is the location of piling. Nevertheless, the piling concentrates in landslide only, not extended further to the left and right flank of landslide that occupied by siliceous argillite of Noni Formation. This is dangerous due to the ongoing surface movement on the left flank of the landslide. The gabion shows significant movement on the surface (Figure 41D). Further up the highland, a few meters from the main scarp of the recent landslide, an actual landslide occurred with a length of around 10 meters. Moreover, the pistol-shaped coconut tree is a possible indication of creeping.

Figure 41. Potential landslide map and indication in field.
