*Relatório de
Investigação Científica INCT 2024*

**GEOSCIENCE INVESTIGATION ON NATIONAL
ROAD FAILURE AT LUGATOI AREA,
VIQUEQUE MUNICIPALITY, TIMOR LESTE**

Dili, Novembro 2024

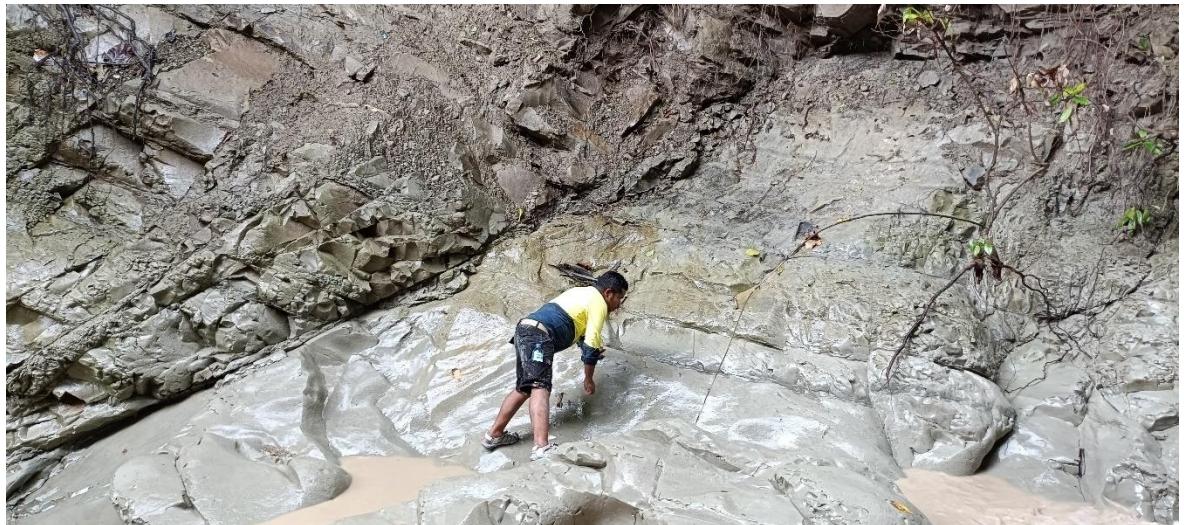
Figure 7. Observing a normal fault

Observing an obvious normal fault occurred on Batu Putih Formation (above), measuring the dip direction of Batu Putih Formation in Cuha River (below). Preliminary interpretations from drone mapping provide essential information for conducting more detailed geological investigations. For example, the discontinuity of topography can reflect geological structures, and high elevation can indicate hard rock formations.

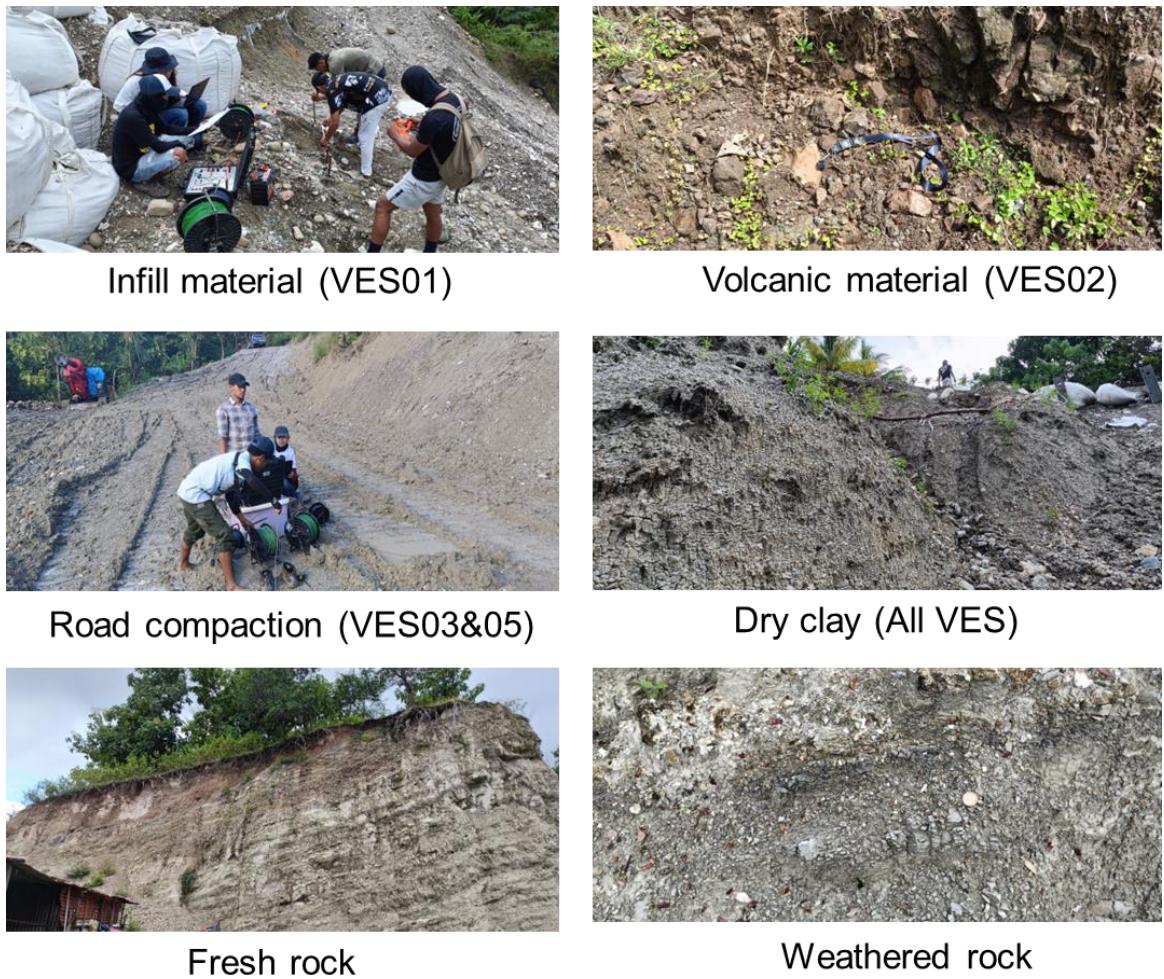
Figure 10. Surface condition of VES site points

The surface condition can be seen in Figure 10. The thickness of these materials around 0.5 m in VES01 and 0.98 m in VES02. Up to this depth (around depth 20-25 m) found the lowest resistivity that reflected the piling diapiric mélange. The VES03, VES04, and VES05 are located in the excavated zone, the surface was compacted for road access. The compaction layers well defined in resistivity profile with depth around 0.7 m to 0.9 m. The subsequent layer is very wet clay material with depth 25 m – 30 m. Finally, the VES07 is located in highland around 20 m from main scarp of landslide that demolishing the road. The top layer is moist soil with thickness 0.38 m, following very wet clay as the product diapiric mélange could reach to depth 20 m. The very wet clay layer interprets the product of diapiric material which is very rare mix with block alien rock causes low values of resistivity.

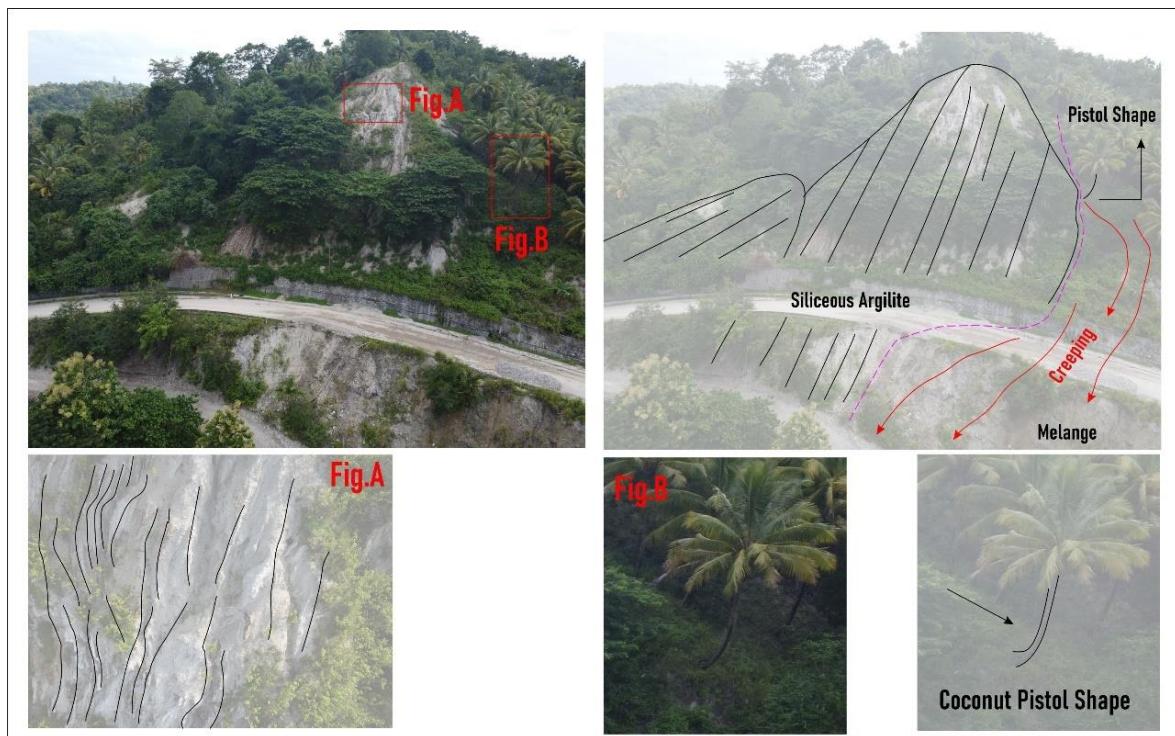
Figure 15. Aerial imagery and DTM data allowing in characterizing the landslide at Lugatoi

The aerial imagery and DTM of drone provide preliminary information prior to detailed field investigation (see Figure 15). Drones creates detailed maps and 3D models view of landslide-prone areas as display in Figure 16. These models help in understanding the topography and identifying potential risk zones. This allowing assessing the dynamics of landslides and predicting future movements. Drones can access remote or dangerous areas that are difficult for humans to reach. This makes them invaluable for surveying landslides in rugged terrains. Before proceeding to the field for ground checks, topography interpretation was conducted. This allows to understand the shape of topography that could related to the local geological structures (see Figure 16).

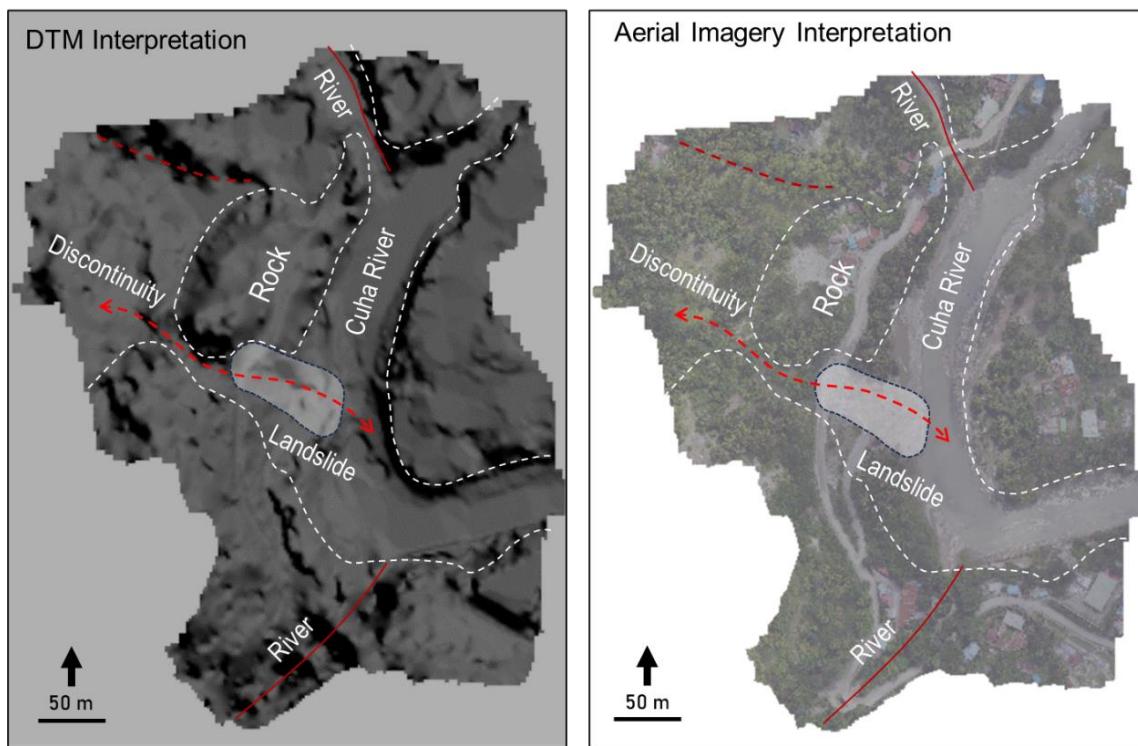
Figure 19. Interpreted drone survey

According to the DTM the surface of study showed four prominent small valley or a discontinuity shape except the Cuha River (see Figure 19). These discontinuities divided the topography into three segments in the west of Cuha River. Two of them are corresponded to the river, and two others with trend northeast-southwest are located on the high elevation that may reflect the structures. In this study the main focus a prominent discontinuity in the middle of study area with trending to the northwest-southeast. This topography feature shows an obvious shape that could occupied by soft rock that triggering road failure. Interpretation of DTM and aerial imagery are aligned to a structure suggest by Duffy *et al* (2013).

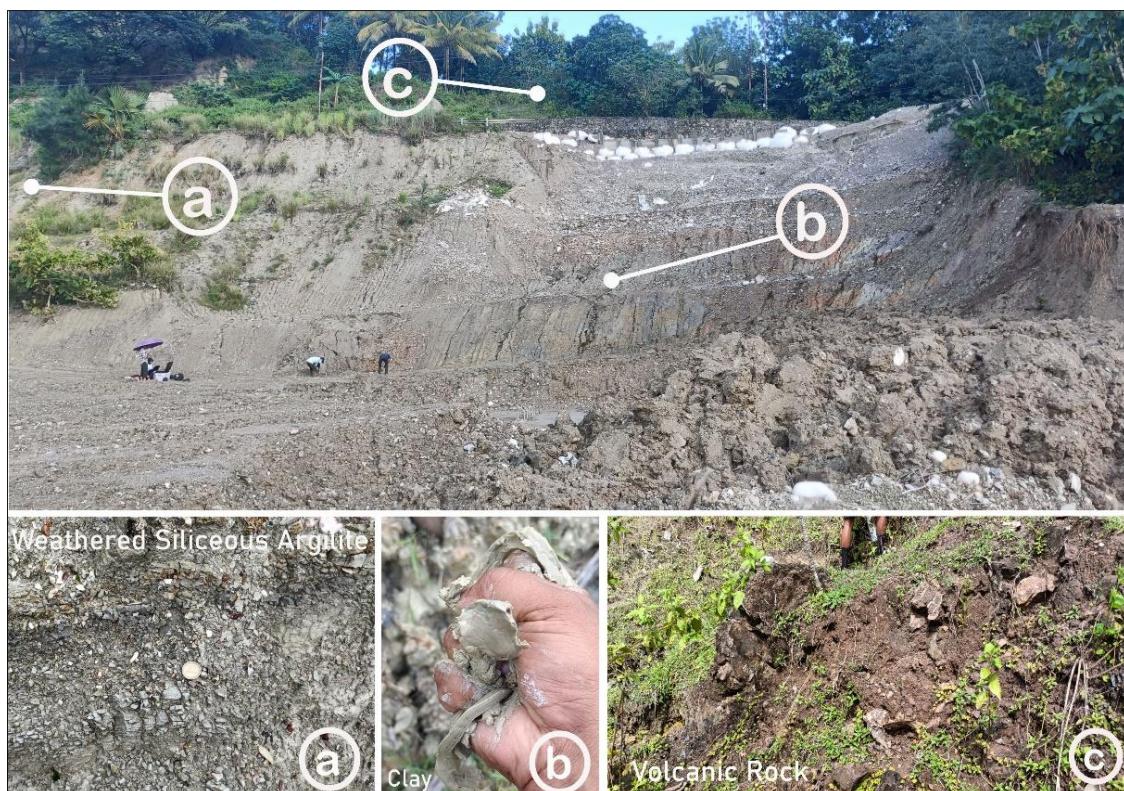
Figure 20.Rock and clay observed along the landslide zone

Lithologically, two three major types of lithologies were identified such as bedding of siliceous argillite called Noni Formation, sand stone interbedded with clay called Viqueque Formation, and clay material contain oldest fragment and block called diapiric mélange material (see Figure 20). The siliceous argillite well observed in the highland, along west of Cuha River. To the south, the bedding Batu Putih formation observed along the two side or river and extended down to the Cuha River (see Figure 8). The contact of

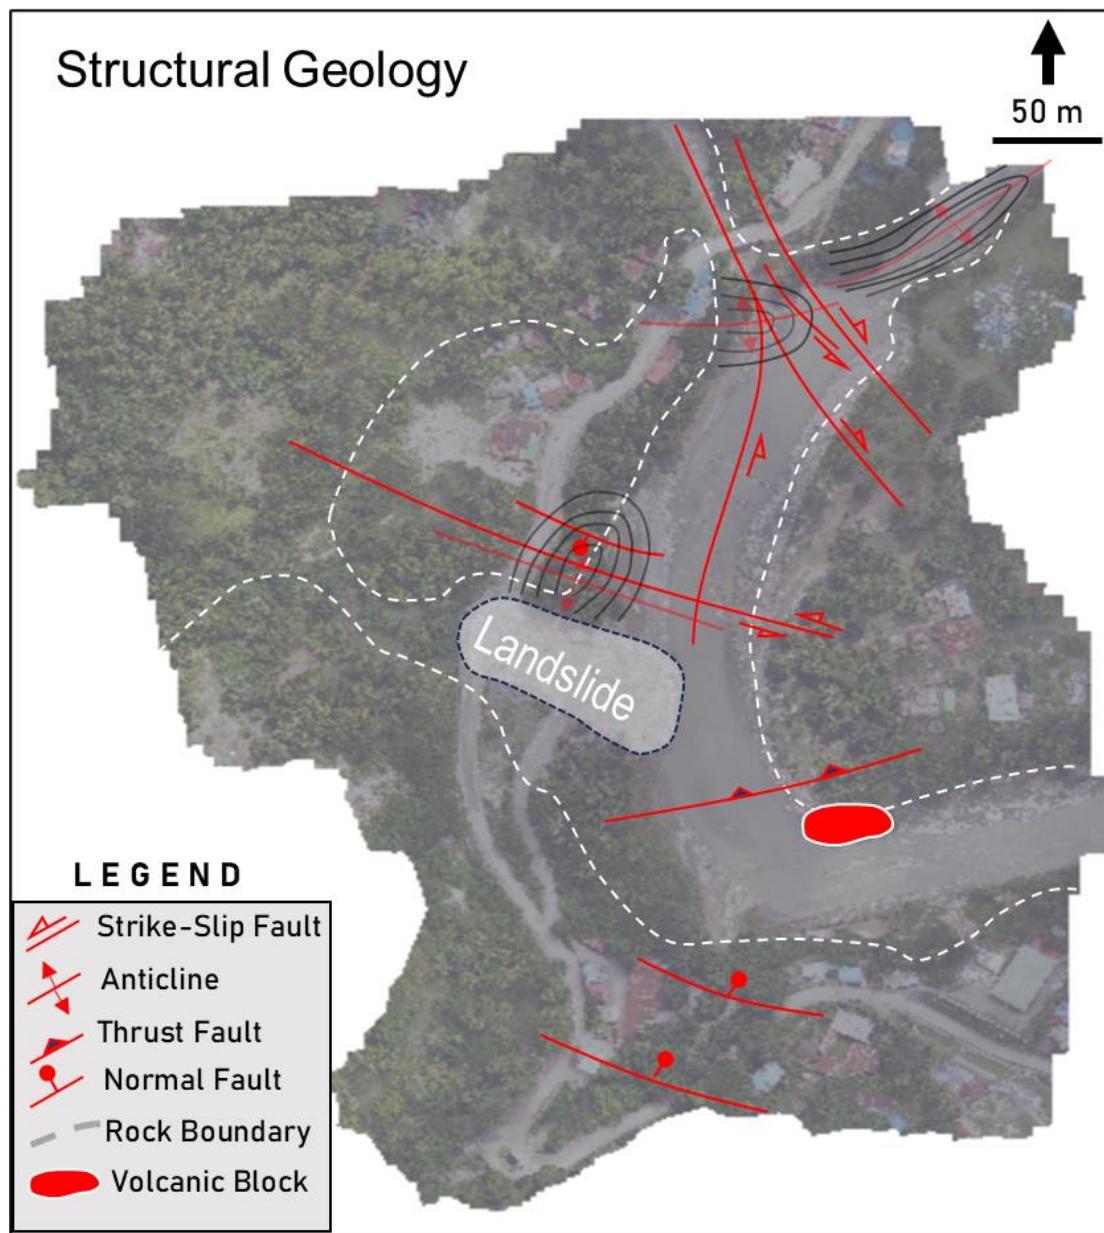
Figure 21. Structural geology overlay on aerial imagery

Structurally, Noni Formation undergone heavy deformation compare to Batu Putih Formation. Noni formation suffered various faults, normal fault, thrust fault, strike slip fault, and folding (see Figure 23). Three major folding on Noni Formation measured, a symmetry anticline is located in north-east of landslide with the fold-axis northwest-southeast, two others in more north-east with the fold-axis northeast-southwest (see Figure 18). In addition, Batu Putih formation undergone tilting and numerous of normal fault that has relationship to rotational fault (see Figure 23). According to the drone mapping, an obvious discontinuity dismembered Noni Formation with direction northwest-southeast. Duffy *et al* (2013) depicted this feature as a fault. Filed observation found that, left-strike slip fault parallel to this structure that cut a symmetry anticline formed on Noni Formation as display in Figure 21. Moreover, the shale smear structure related to the normal fault also observed in the limb of anticline as demonstrates in Figure 22. This could interpret that a left-strike slip fault overprinted on Noni formation as the main path way for overpressure material escaping to the surface. Therefore, the fault zone mostly covered by the material of diapiric mélange zone. Further to the north-east, two others folding overprinted by multiple strike-slip fault. This coincides the small river in the north-east of landslide (see Figure 21).

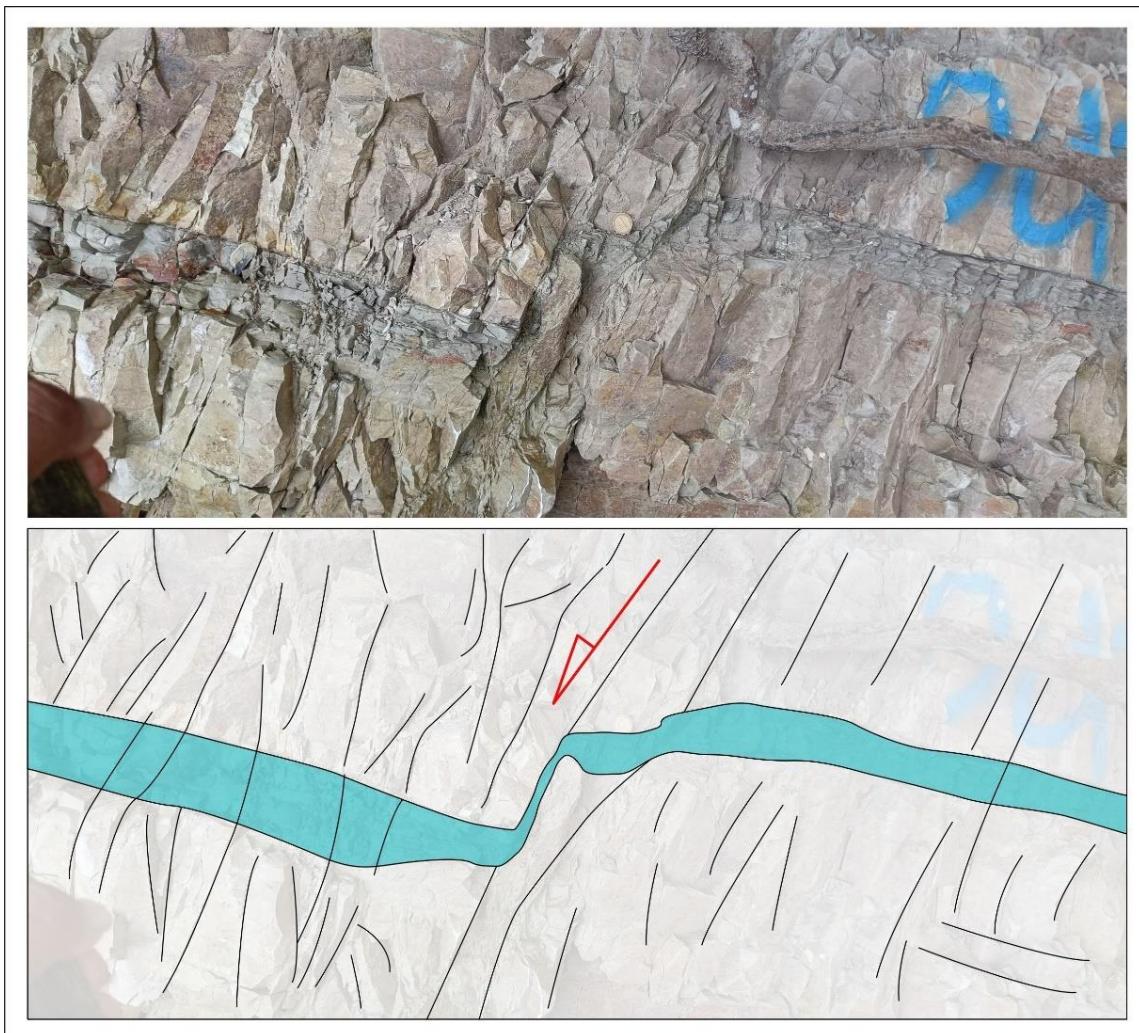
Figure 22. Shale smear in a normal fault

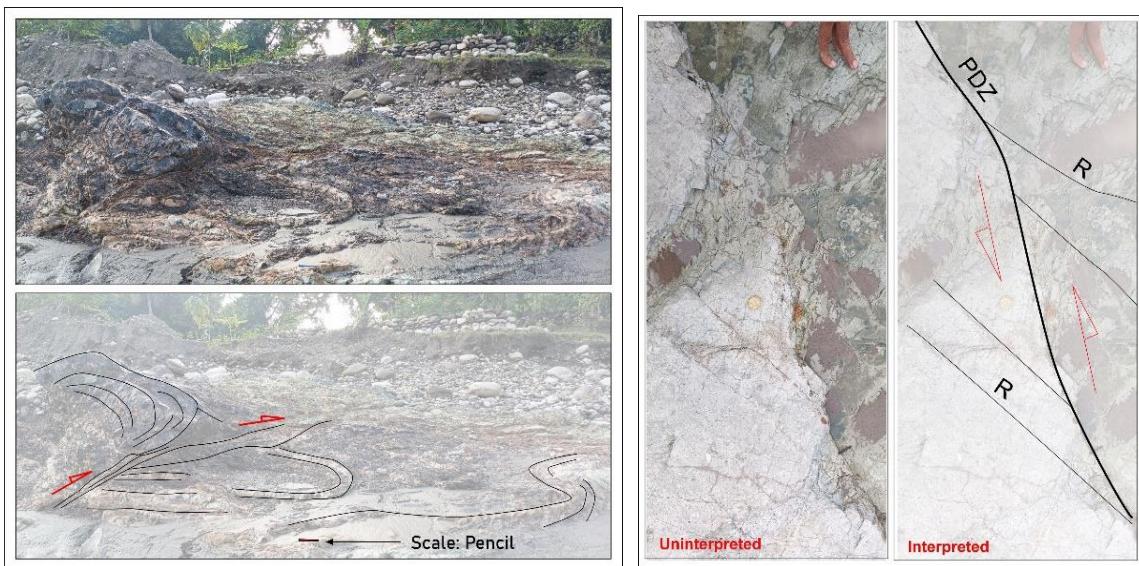
Figure 23. Thrust fault observed on siliceous argillite (left), Rieder shear shows left strike slip fault on siliceous argillite (right)

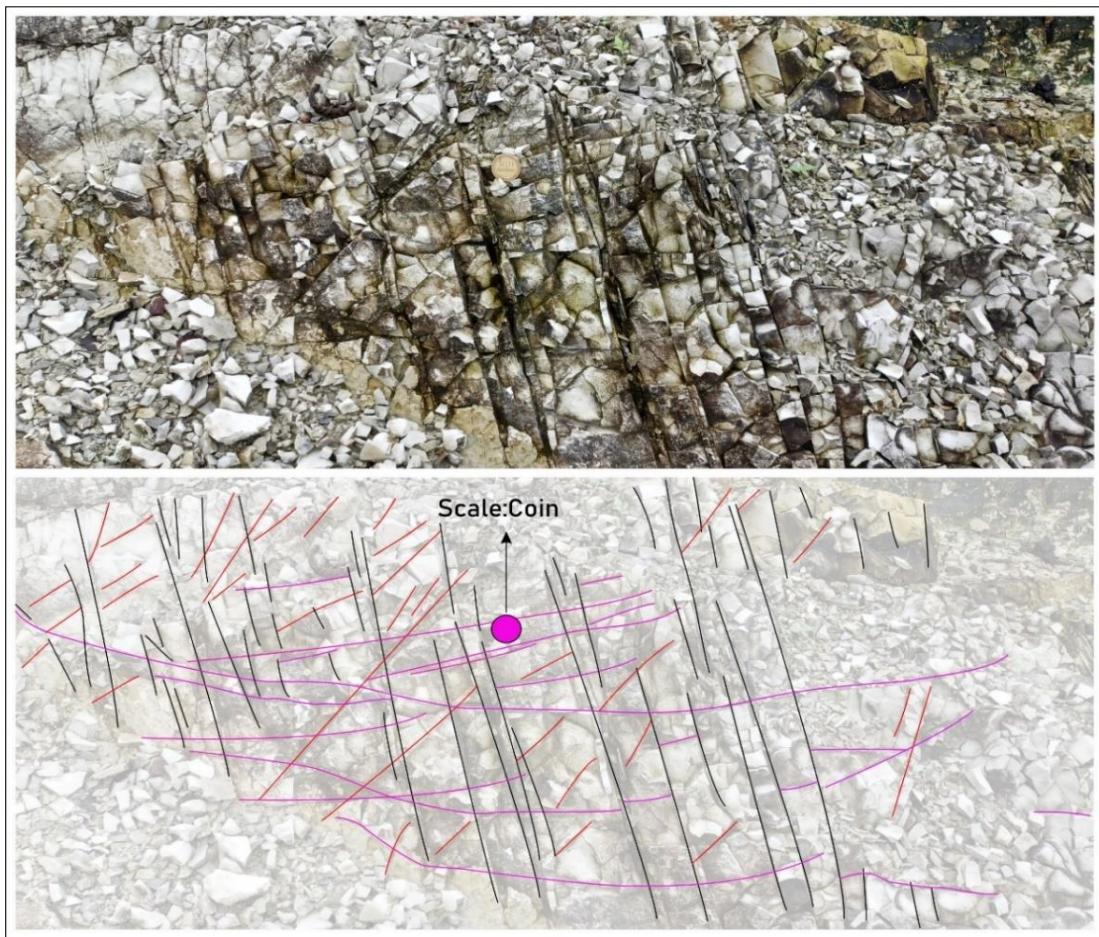
Figure 24. Joint system on siliceous argillite

Besides major faults, the Noni Formation undergone multiple joints. According to the field observation, in the highland a joint system comprising of four joint set as display in Figure 24. Further to the, bank of river the joints mostly parallel to the major fault. In other hand, along the joints found kaolin rich-zone (see Figure 27). The existing joints has vital influence to level of rock weathering. In the highland, both left and right side of landslide the weathering is high compare to the outcrops along the bank of river. Possible this because of exogenic role has major influence.

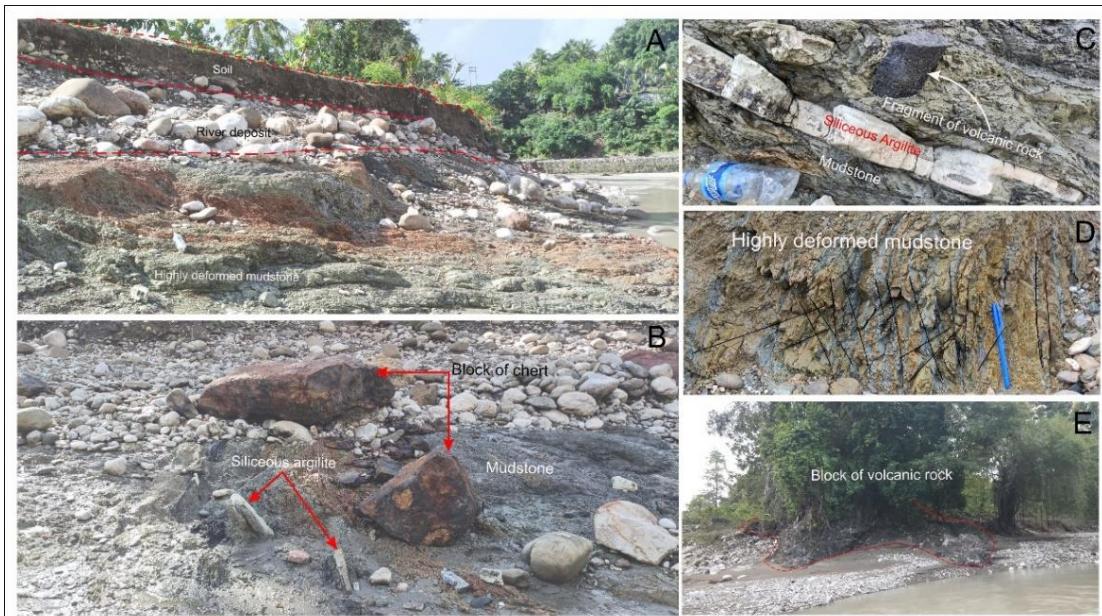
Figure 25. Mudstone undergone high deformation and various block were embedded into the mudstone.

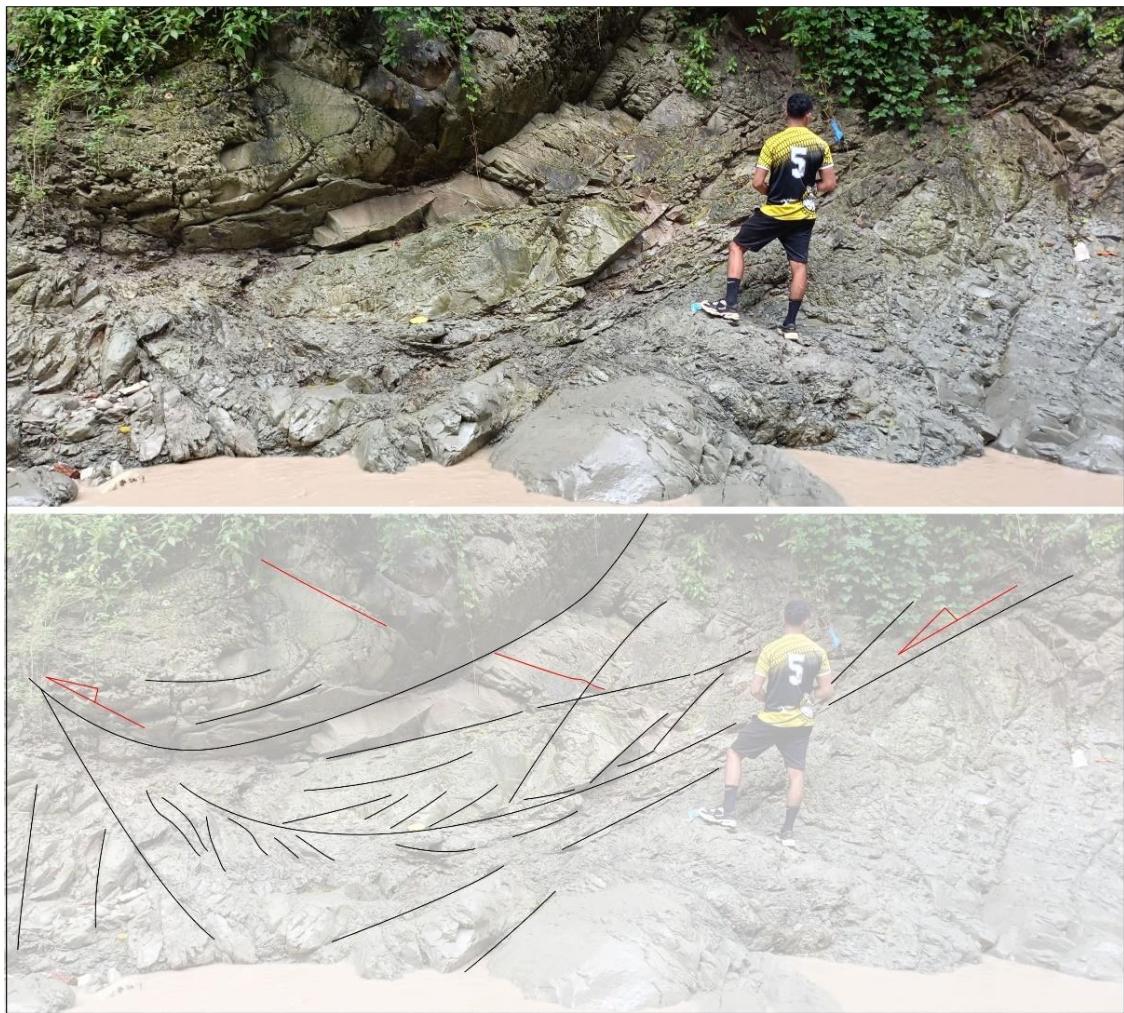
Figure 26.Rotational fault occurred on Batu Putih formation

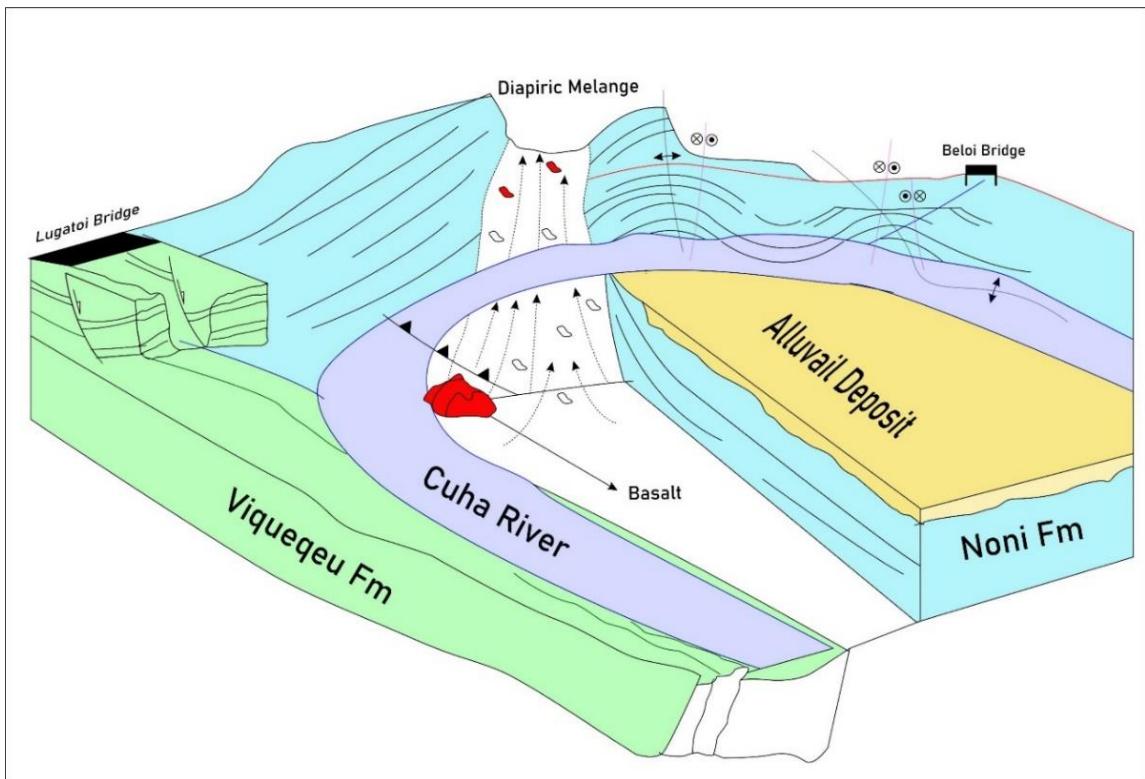
From various combination of data 3D model view was developed as display in Figure 28. This 3D view from southeast-northwest. In the left and right side of model observed Noni Formation which has opposite dip direction. In the right side observed two folding on Noni Formation with fold axis to the northwest-southeast. Numerous offsets were observed along the folding, the offset indicates left and right-strike slip fault parallel to the fold axis of folds. Further to the left side the siliceous argillite has steep dipping. This area mostly undergone high level of weathering. Joint set observed easily along the surface of outcrop. In between two Noni Formation mostly covered by the clay particle. This clay particle interpreted as the product of diapiric melange. This fascinating geological process were unconsolidated mud or shale, often under high pressure in convergent plate boundaries. The thickness of this mud diapiric believed

up to hundred meters below the surface. Therefore, mud diapirs can pose hazards to infrastructure due to their potential to cause ground deformation and instability.

Figure 28.3D geological map view from south

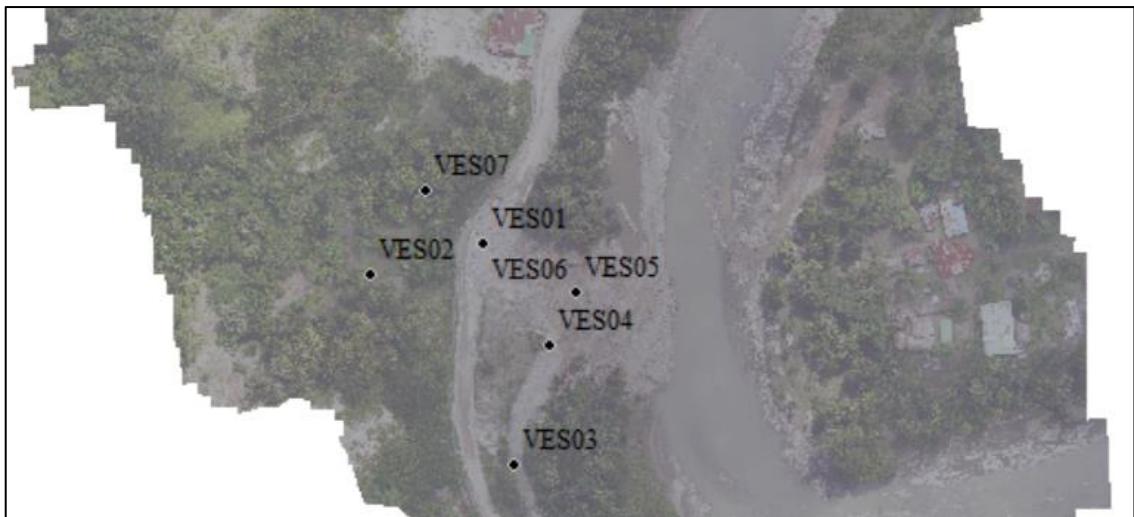
Six VES points used Schlumberger protocol were measured. Three VES points were located linearly within the landslide, remaining points were out of landslide (see Figure 32). The graphic of inversion each point as displayed in Figure 33. The x-axis represents the AB/2 value while the y-axis represents the resistivity value of subsurface material.

Figure 32. Location of VES point

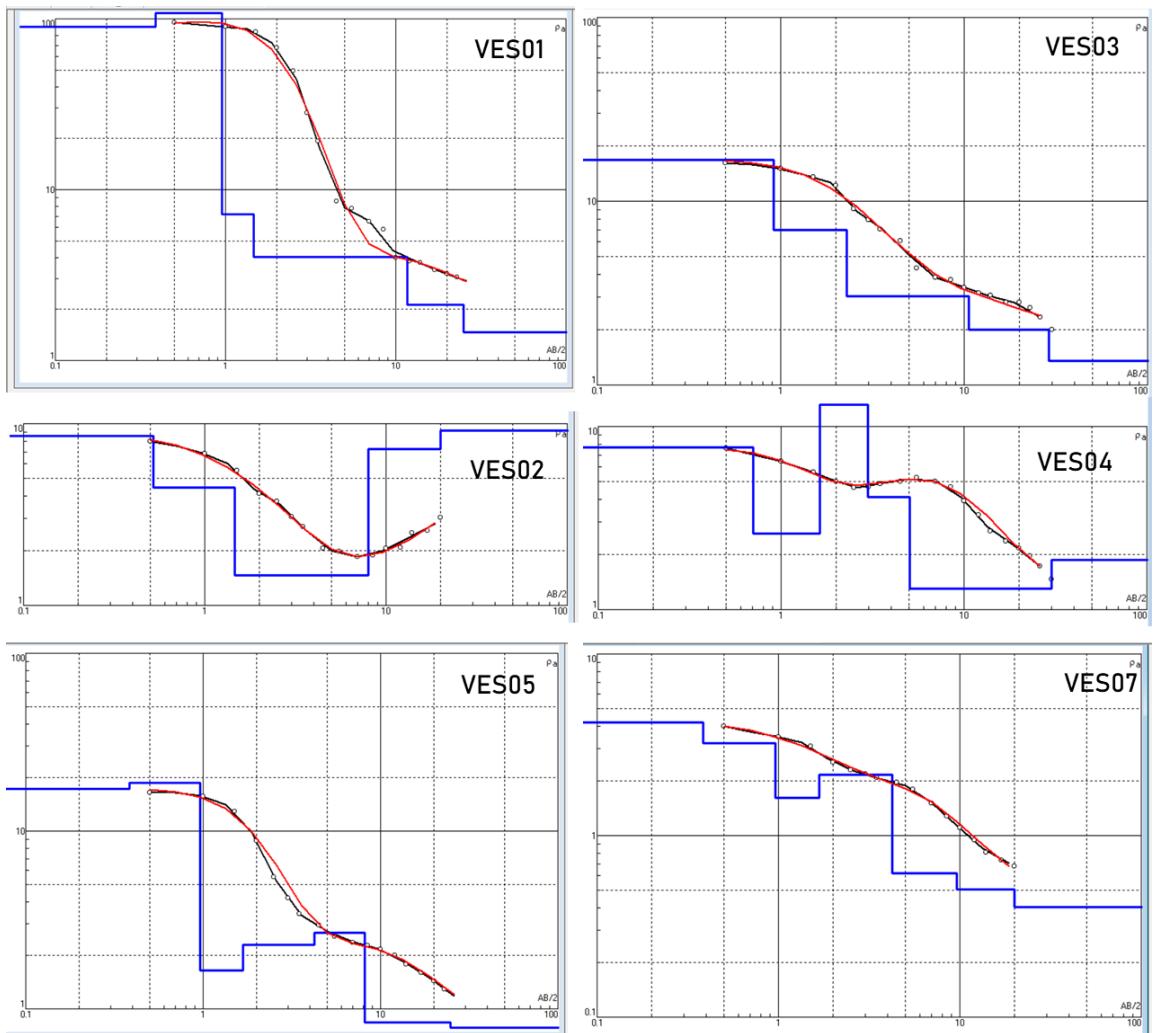
Varying of electrodes spacing allows obtain the information at different depths. Variations of subsurface resistivity values may help in distinguishing the geological layers and their properties. As displayed in Figure 33, each VES point undergone gradual to steep decreasing resistivity values. Fluctuation of observed and obtained model in each graphic reflect the different lithologies and their properties beneath the surface of study area. Moreover, different lithologies and properties could be used to predict the water table and candidate failure surface.

According to the space, allowing the penetration depth of VES line varies from 20 m to 30 m. Obtained resistivity value are ranged from 1 ohm-m to 273 ohm-m. The highest value interpreted as the volcanic material that embedded into the clay. While middle to lowest value reflected to wet clay and very wet clay. Decreasing of value due to the increasing moisture content in soil, and this often has strong relationship to the higher percentage of fine clay particle. In other hand quantity of water in clay has significant effect on resistivity value. In addition, particle size distribution of clay determines the degree of water saturation. (Kalinski & Kelly, 1993) revealed that increasing of water conductivity that occupied in pores space reducing the resistivity value. The very wet clay of each point is observed at depth 0.5 m to 6 m. Presence of very wet clay layers are well agreeable to the emergence of natural spring along the landslide zone. This because unwell surface water treatment in highland of landslide zone.

Figure 33. Inversion of VES data

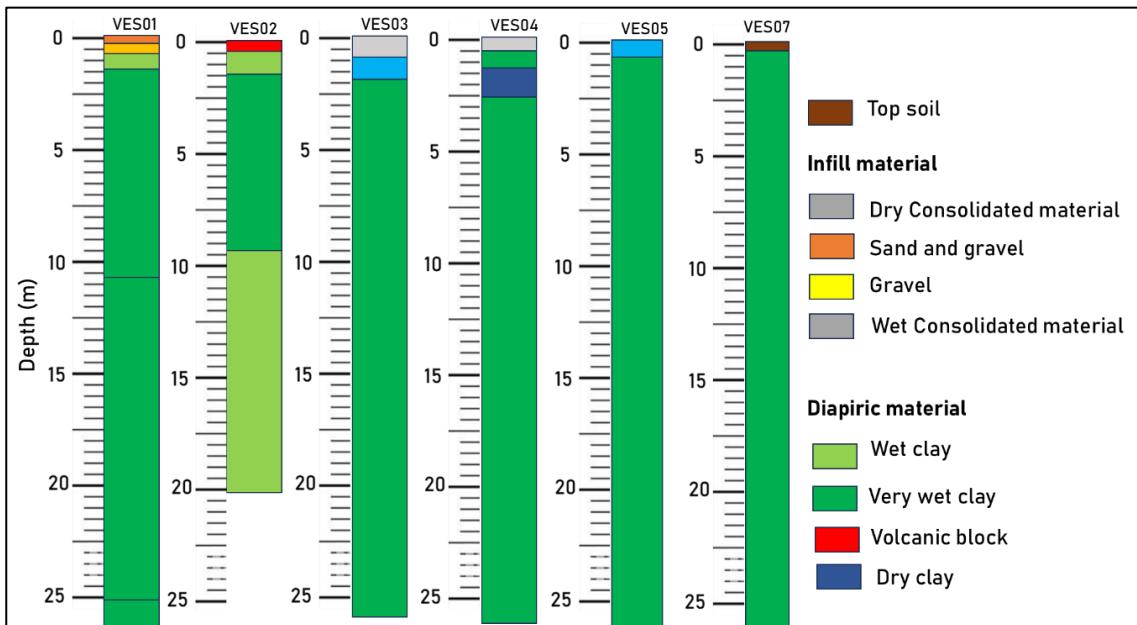
In Figure 34, profile of VES data was built according to the Table 1. The models display variations of resistivity value beneath the surface. Overall, the VES01 and VES02 show different material in the top layer, where the increasing of resistivity value due to the infill material of sand gravel and volcanic material respectively.

Figure 34. VES profile in study area

In this study the VES model well reveal the variations of resistivity values the useful in determining the degree of saturation below the road failure and surrounding area. This could allow us in characterizing the landslide due increasing of water saturation reduce the internal cohesion of soil (Crawford and Bryson, 2018). Moreover, resistivity values depend on the degree of compaction, water content, degree of saturation, porosity, and clay content, all of which are strongly related to geotechnical purposes. Furthermore, the VES data could guide the engineer to locate the borehole, and may helping in eliminating less favorable alternative sites.

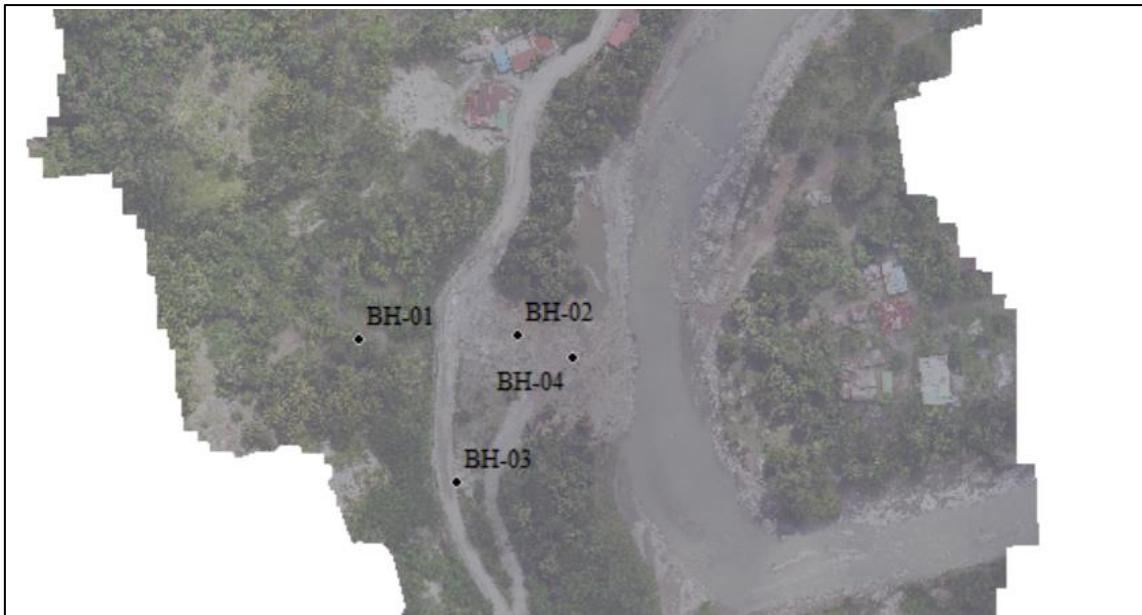
In this survey, four sample for mechanical and physical test were collected. The location of sample collection as display in Figure 36. In particularly, the shear strength analysis applied only for three samples (BH1, BH2, BH3) due one sample (BH4) was collected by heavy machine of company was constructing the road maintenance (piling method). Prior to collecting sample, defining sample location that representative of the soil conditions based on geological information. BH1 was collected in the highland beyond the landslide zone. BH2 and BH4 were collected in the landslide zone. BH3 collected on a weathered outcrop of siliceous argillite in left-side of landslide (see Figure 36 and 37). For BH1, BH2 and BH3 sampled disturbed sample using hand auger. While, undisturbed sample tubes to

Figure 36. Location Geotech samples.

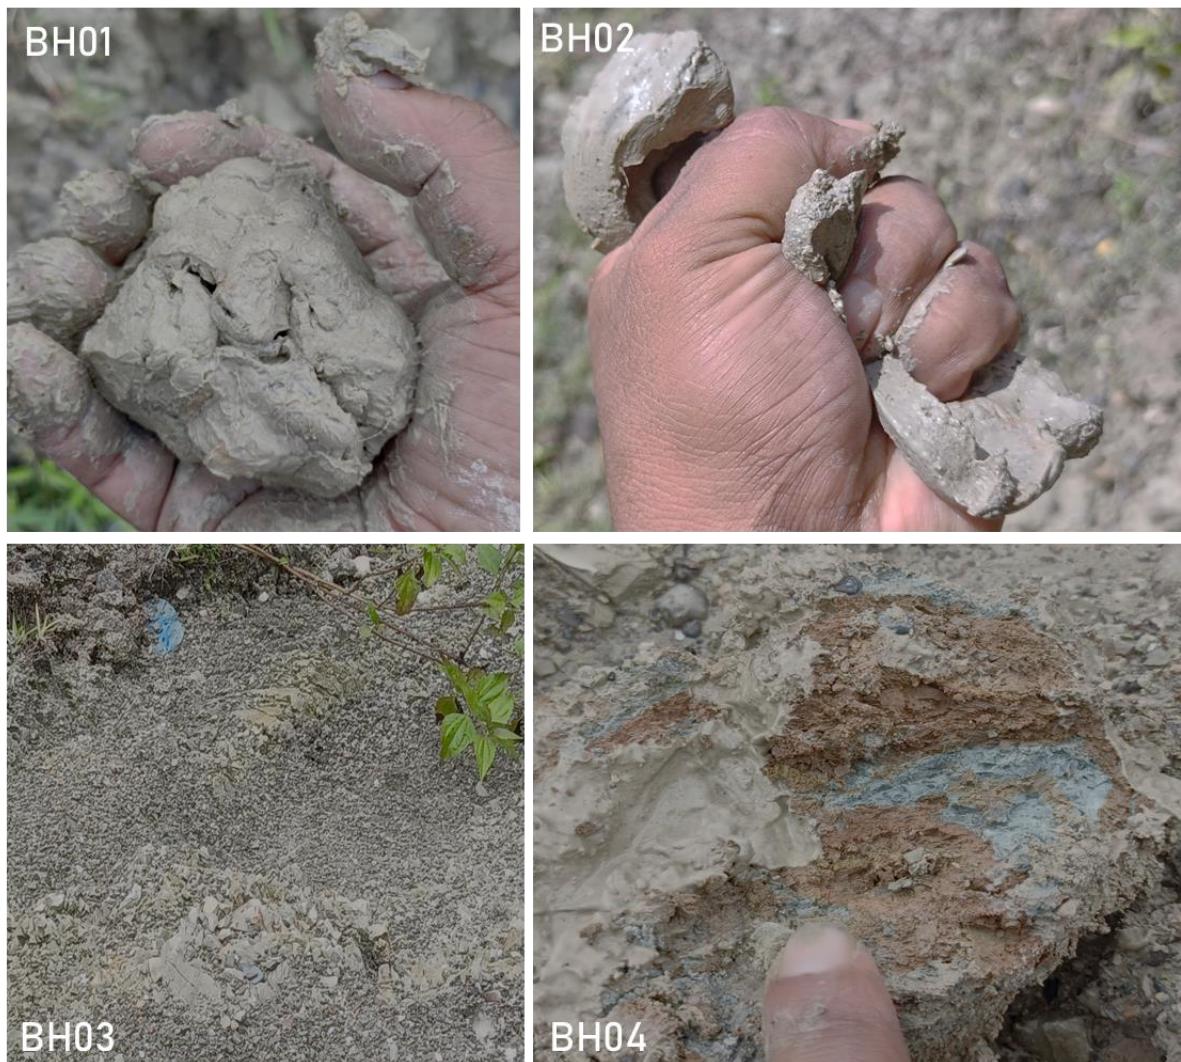
preserve original soil structure. Samples of BH1, BH2, and BH3 collected on origin material with a depth 50 cm. BH4 sampled at depth 6 m. The physical character of samples as illustrates in Figure 37.

According to test in the field using finger to very wet clay samples (BH1 and BH2), both samples have high plasticity due to it flowing in between fingers. This because of increasing of water into the surface and poor surface water treatment. Increasing of plasticity indicates abundance of clay material. This wet clay tends to be weaker due to its reduced shear strength and increased plasticity, posing challenges for foundation stability.

Figure 37. Character of soil and rock samples
